### MARYLAND HISTORICAL TRUST

#### INVENTORY FORM FOR STATE HISTORIC SITES SURVEY

B-1867 830 Tyson Street, Baltimore Sanborn Map, 1914 (revised 1953)

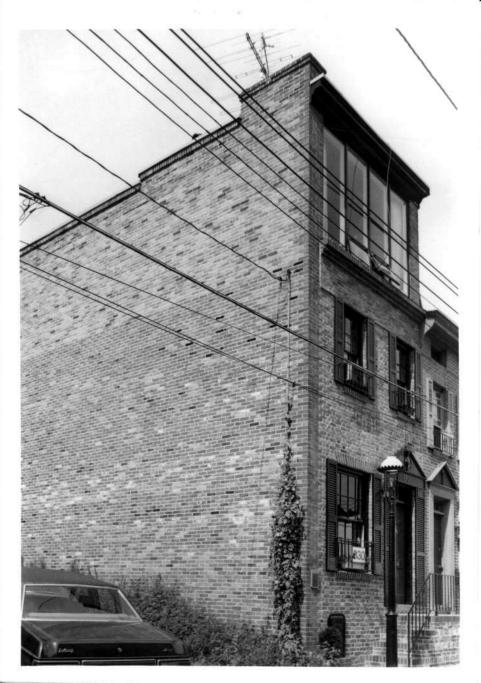
830 Tyson St

This 3 story house demontrates the peculiar effect of at least 2 remodeling projects. It probably once was similar to the 22 story house to the right, but at some time the roof was raised to form a full third story. A recent owner, desiring to "Colonialize" the building rebuilt the entire street facade, the first 2 floors in flemish bond. He restored the cornice line and relief brick courses below it, but was unwilling to give up the extra space of the thrid floor where he installed 4 huge floor to ceiling windows. Though the lower two floors are arranged in 2 bays like the other houses, the size and placement of the windows have been chnaged.

These alterations together with the poor design of the details are an example of a wall intended but poorly executed renovation. The right bay is the entrance which is reached by 4 brick stairs which run parallel to the facade. Like the 3 houses to its right shares one of two double stooped, each with an iron railing. There is a cast iron coal door to the left of the stoop. The 6 panel door with transoms, has two wooden blinds and a stock "Colonial" split pediment which extends to the outside edges of the blinds. The 8-over-8 window has wood blinds, brick sills, splayed brick lintel and a modern window basket incorporating a plague with the house humbler.

The two second floor windows are 6-over-6 double hung, with two narrow wood blinds, window baskets and brick sills. They are set immediately below the cornice. This cornice is formed by three courses of corbeled bricks.

Except for two brick piers at the side walls, all of the 3rd floor facade is of glass. This huge window consists of 4 vertical panels. The bottom portion of the 2 center sections is hinged at the top. There is a wood cornice at the roof line.

Basket weave patterned brick paving surfaces the sidewalk in front of this house and the 2 houses to the right.
